# Evaluation of Corrosion and Wear of Non-Skid Deck Surfaces in Marine Environments

**Evaluation of Corrosion and Wear of Non-Skid Deck Surfaces in Marine Environments**

A Thesis

in Mechanical Engineering

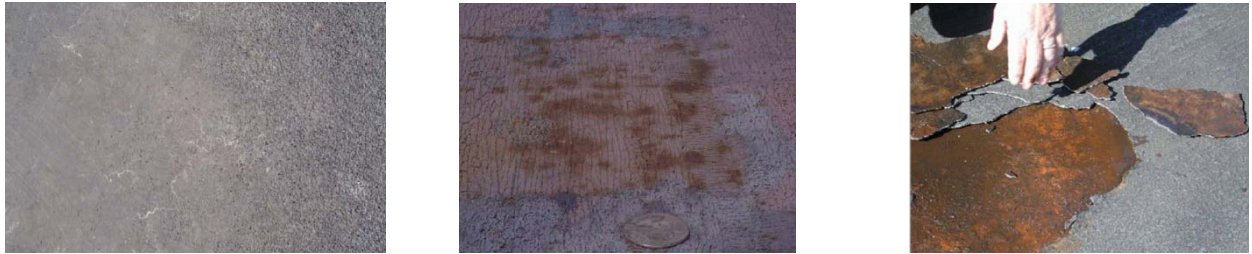
Figure 1: Traditional Non-Skid, Wear (left), Corrosion (middle), Failure (right)  
from: (Dust, 2008)

It has required service life of 12 months, but the decks are generally re-surfaced every 2-3 years at a cost of \$3.20 per square foot, not including labor costs. Successful installation is highly weather dependent and labor intensive. One of the problems associated with non-skid failures is Foreign Object Debris (FOD) on flight decks. Before flight operations, members of a ship's crew must walk over the flight deck and pick up any FOD so that it is not sucked into a helicopter's engine. The majority of FOD is small pieces of non-skid material.

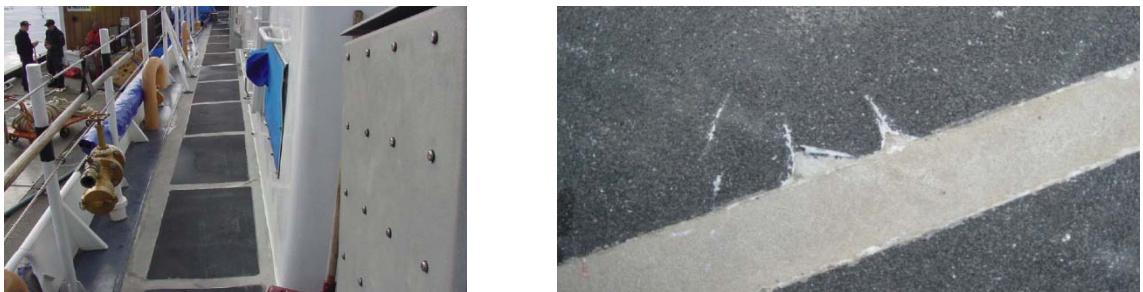
Figure 2: Peel and Stick Non-Skid, 110' Patrol Boat (left), Edge Failure (right)  
from: (Dust, 2007)

Approved for use in 2009, the material consists of abrasive particles (aluminum oxide or silicon carbide) embedded into a polymer backing with the reverse side coated with a pressure sensitive adhesive. The product generally used is 3M Safetywalk 700 Series. The recommended service life is approximately 3 years. The cost to replace the decking on a 110 foot patrol boat is \$15,302 or \$6.10 per square foot. The base cost of the material is \$4.50 per square foot, with higher prices for ship specific kits with pieces cut to fit the unique curvature and areas of the deck. It may be applied to a steel or aluminum deck.

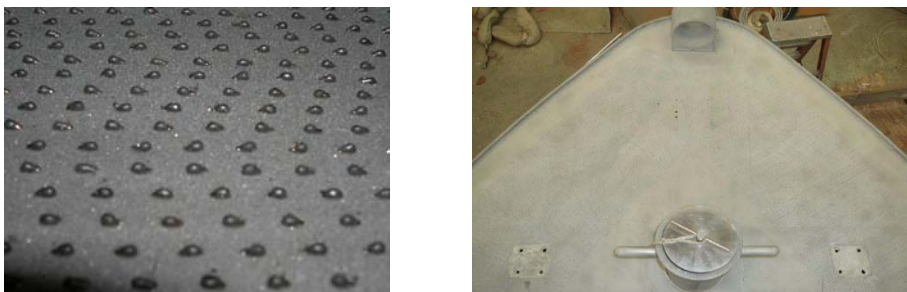
Figure 3: Laser Deposited Non-Skid, Steel with LDN (left), LDN on 41' UTB (right)  
from: (Dust 2007 & 2008)

Ross Technology Incorporated has developed a slip-resistant flooring product known as Algrip™. Ross specializes in providing Algrip™ safety floor plates for use in industrial environments, such as stair treads, platforms, and walkways in food processing plants, oil rigs, and other facilities. The Algrip™ flooring product is manufactured by using a patented CNC laser deposition process that essentially welds beads of alloy material onto a plate of carbon steel, stainless steel, or aluminum.

The USCG is currently investigating the use of this LDN for use on their 41 foot Utility Boat (aluminum deck) instead of the “peel and stick” material currently used. The USCG is interested in determining if it is feasible for use on other platforms.

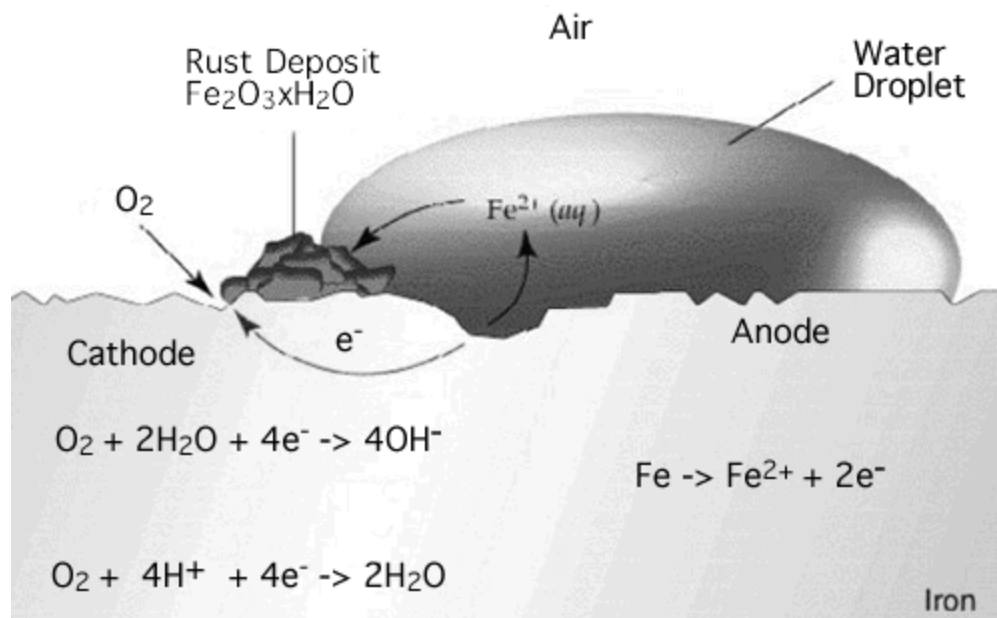
Figure 5: Corrosion of Iron  
from: <http://www.splung.com/contents/sid/3/page/batteries>

Rust forms when the hydrogen ions are consumed and as the iron corrodes, the pH in the water rises. Hydroxide ions ( $\text{OH}^-$ ) form as the hydrogen ion concentration falls and react with the iron to produce rust (<http://corrosion-doctors.org/Experiments/rust-chemistry.htm>).

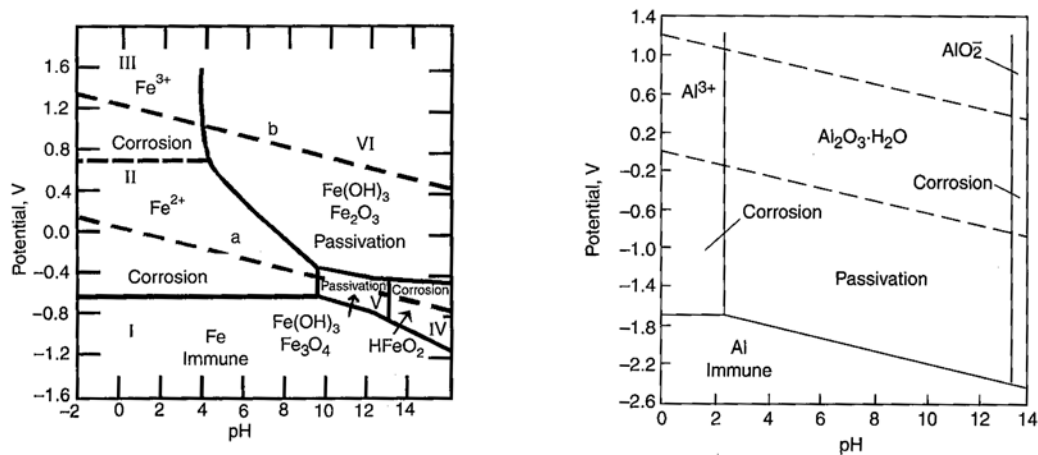
Figure 6: Pourbaix Diagrams for Iron in Water (left) and Aluminum in Water (right) from: (Kramer 2003)

Corrosion rates may not be determined from the Emf Series, and are influenced by many factors including temperature, humidity, pH, composition of the material, composition of the corrosion product, and type of corrosion. Varied environmental factors obviously make it difficult to predict corrosion rates. Pourbaix diagrams are useful for determining if a material will corrode under a certain condition. These diagrams show areas of the material which are thermodynamically stable over a range of pH and electrochemical potential. Seawater has a pH range of 7.5 to 8.4. By looking at the Pourbaix diagrams below for iron in water and aluminum in water, the regions of metal stability and regions of corrosion may be seen given the standard potentials of iron and aluminum (-0.44 and -1.66 respectively, Figure 4). In the range of seawater, it can be seen that iron will corrode, but aluminum will not (Kramer 2008).

So according to the Emf Series, aluminum is more active than iron; so why does it show less signs of corrosion? Aluminum is an active metal and corrodes by quickly forming a thin layer of aluminum oxide, which is “instantly self-renewing” and protects the aluminum from further corrosion. Contrary to rust on steel, the aluminum oxide is chemically bound to the surface and does not flake off like rust (Perryman 2007). Aluminum corrosion is typically a victim of galvanic corrosion rather than general uniform attack corrosion, evident through pitting. Characteristics of marine grade aluminums will be discussed in the methodology section.

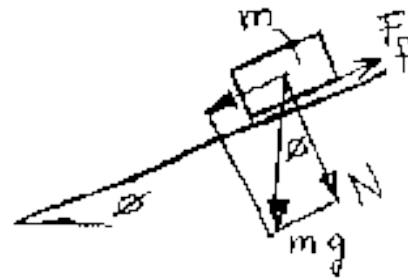
Figure 7: Tilted Plane Method of Measuring COF  
from: <http://www.tribology-abc.com/abc/friction.html>

$$\mu = \frac{F_f}{N} \text{ or } \mu = \tan \phi$$

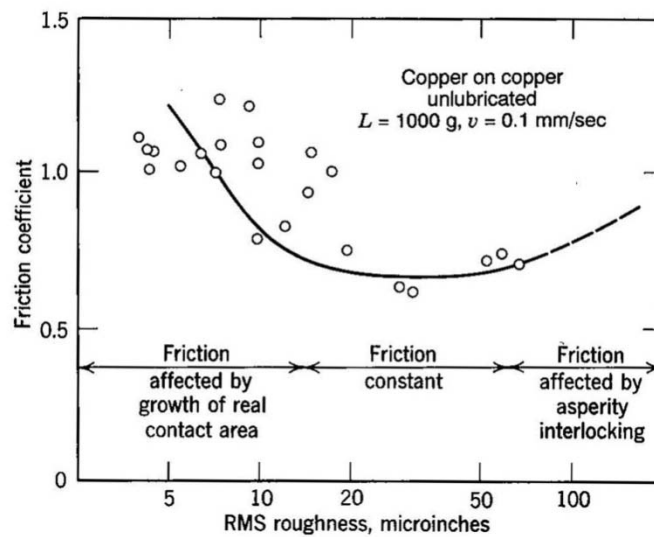
Figure 8: Plot of Friction Against Roughness  
from: (Rabinowicz 1995)

function of the normal force pushing the surfaces together (Bayer 2004). Therefore friction should be an important factor in surface roughness since it directly affects the real area of contact of surfaces due to the changes in contact area. Rabinowicz showed that for unlubricated copper on copper, the friction was high in smooth regions because of the high area of contact, while with rough surfaces the friction is high because of asperities hitting on lifting over each other. In between the friction is minimized and could be independent of roughness (Rabinowicz 1995). The research presented will explore relationships among friction, wear, and roughness in non-skid materials by characterizing the surfaces to discriminate the textures and establish functional correlations.

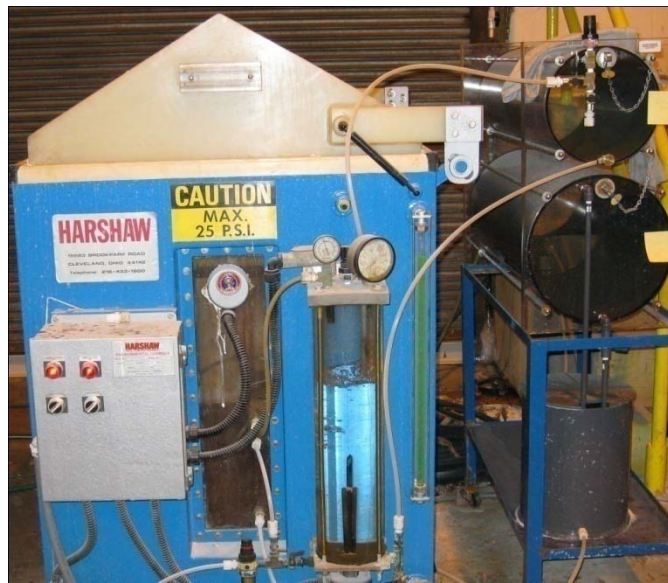
Figure 11: Salt Fog Testing Chamber at Ross Technology. Harshaw Environmental Chamber, Model 22, 3 Phase, 240 Volts, 60 Hz, 13 Amps. Made by Harshaw Chemical Co., Cleveland, Ohio.

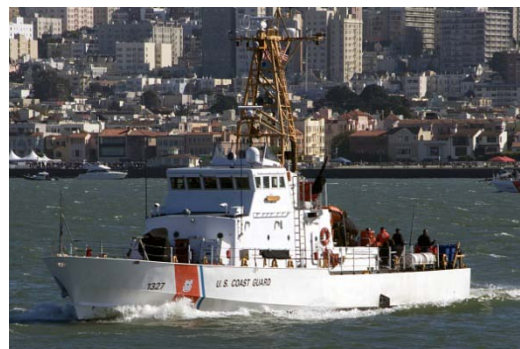
Figure 12: Frame for Samples (above) and 110' Patrol Boat (right) from:  
<http://reference.findtarget.com/search/List%20of%20United%20States%20Coast%20Guard%20cutters>

On February 5, 2010 a set of 12 samples were taken to Key West, Florida for placement on CGC KODIAK ISLAND, a 110 foot patrol boat. Wood frames were built to hold the samples in order to prevent galvanic couples when attaching the samples to the ship. The wood frames were attached on the bow of the ship under the grating system that supports the 25 mm machine gun. The samples were placed in an area that receives ample amounts of sun and seawater. The samples remained onboard for the duration of a patrol in the Caribbean Sea for 36 days (864 hours).

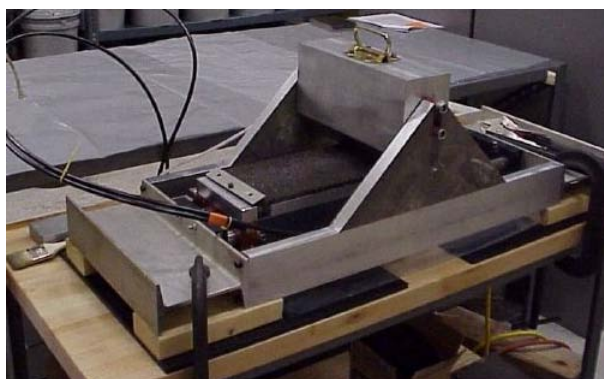
Figure 13: Wear Testing Apparatus  
from: (Tricou and Kelly 2008)

Samples were taken to the Pennsylvania State University ARL for wear testing March 17 -19, 2010. The wear testing was completed using a cable abrasion tester built at the ARL in accordance with the Military Performance Specification 24667B, sections 4.5.4 and 4.5.2.1. The apparatus consists of a jig to hold the non-skid test panel and a 30 pound weighted carriage holding a steel rod. The carriage was moved in a reciprocating fashion over the long axis of the test panel. The steel wire abrading the surface was  $\frac{1}{8}$ " diameter high carbon spring steel with a class 2 temper. The steel wire is the type of wire used in strands of the arresting cables used on US Navy aircraft carriers. The 500 cycle wear test is intended to replicate the amount of wear experienced on a Navy ship in operation over a 2 year period. All samples were weighed and photographed before and after wear and the pictures are contained in Appendix 4.

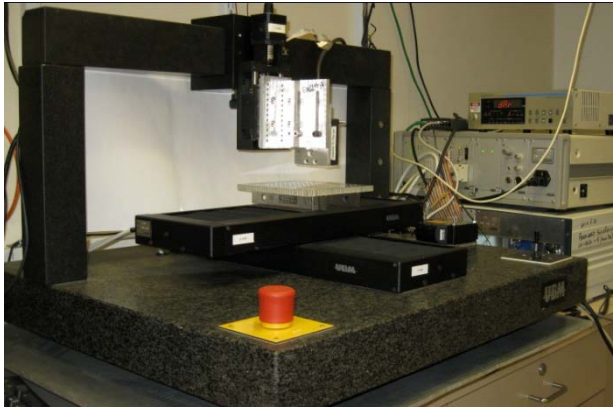
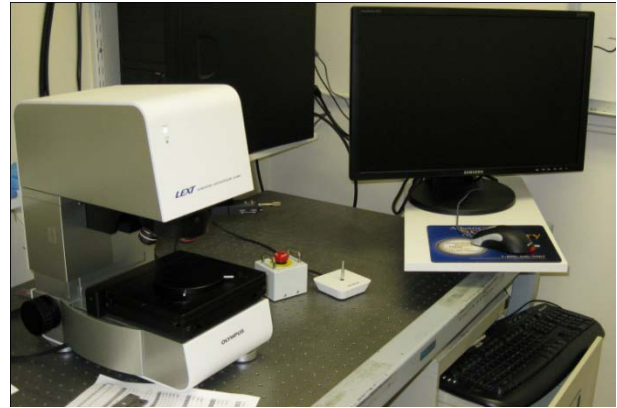
Figure 15: UBM Scanning Laser Profiler (left) and Olympus LEXT OLS 4000 confocal microscope in the Surface Metrology Lab

The TNS and LDN non-skid samples were measured before and after wear using the Olympus LEXT OLS 4000 vertical scanning laser confocal microscope. Measurements were taken with the 20X lens using the stitching feature with 10 percent overlap to produce a measurement area of 1.8 mm x 1.8mm.

- Light Source: 405 nm semiconductor laser
- Optical zoom of 1x to 8x
- Scale resolution of 0.8 nm
- Display resolution of 1 nm

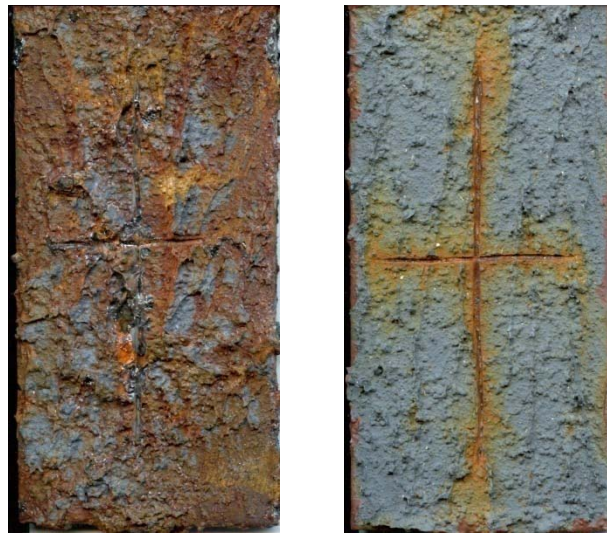
Figure 16: TNS A36 sample post corrosion testing, 1000 hours of salt fog chamber (left) and 864 hours On USCGC KODIAK ISLAND

The salt fog chamber and environmental corrosion tests produced highly visual results – the level of corrosion among samples was easily seen without quantifying the results. The salt fog chamber corrosion samples were much more corroded than the set of samples placed on CGC KODIAK ISLAND. The result was expected since the salt fog chamber test was 136 hours longer and it maintained constant humidity and temperature while the daily temperature and humidity level varied while the cutter was underway. Images of the different corrosion tests are shown below in figure 16 for the TNS A36 sample; the differences in corrosion severity are evident.

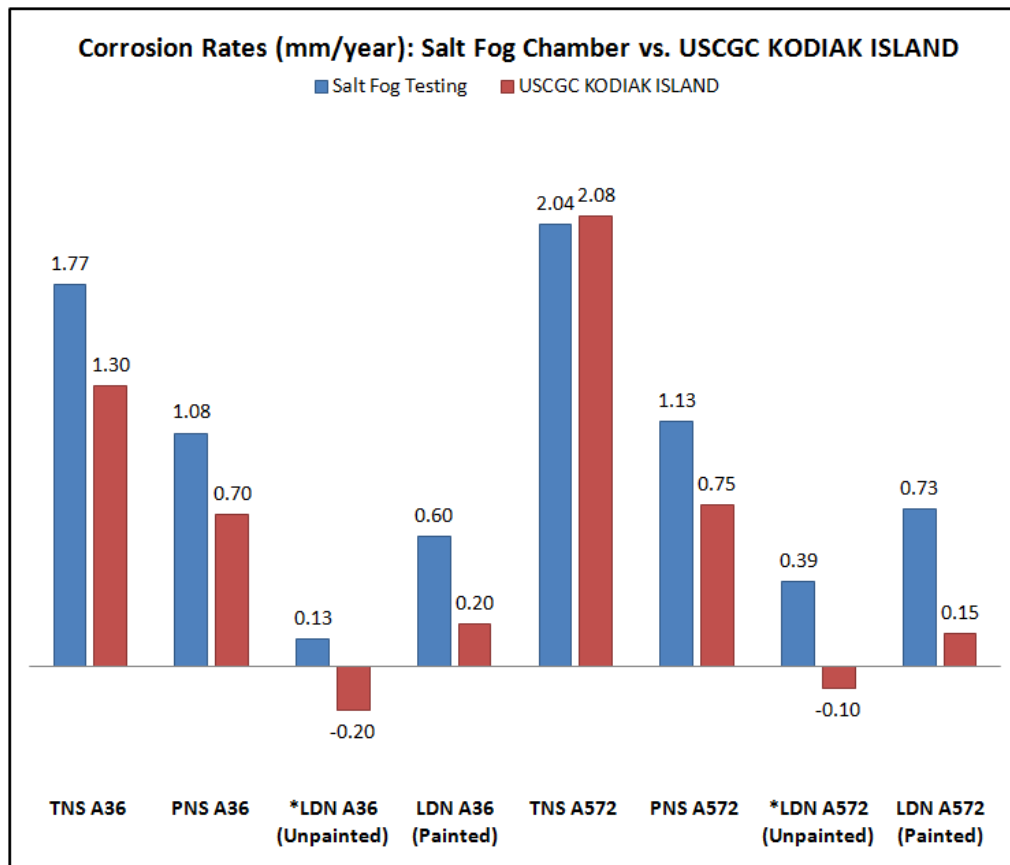
Figure 17: Corrosion rates of samples corroding in a salt fog test chamber to samples corroding onboard the USCGC KODIAK ISLAND.

Using the Clemex™ PE image analysis software, the percentage of area corroded was calculated for each sample. In the salt fog tests, the PNS experienced the highest percent of area corrosion, while onboard the cutter, the TNS was highest. In both test, the LDN had the lowest area percent of corrosion. The PNS corrosion seemed to experience “undercutting corrosion” due to water seeping in around the sealed edges while the TNS showed signs of “through corrosion” where water penetrated the non-skid material through small cracks in the coating. The large area percent corrosion of the TNS was surprising since this material is the predominant deck material on all large steel hulled ships in the USCG and Navy. The negative corrosion rates for the unpainted LDN steel samples are not a good indicator of the actual corrosion rate, rather the corrosion product was so thick that it could not be sufficiently removed and the ending mass was higher than the initial mass of the sample.

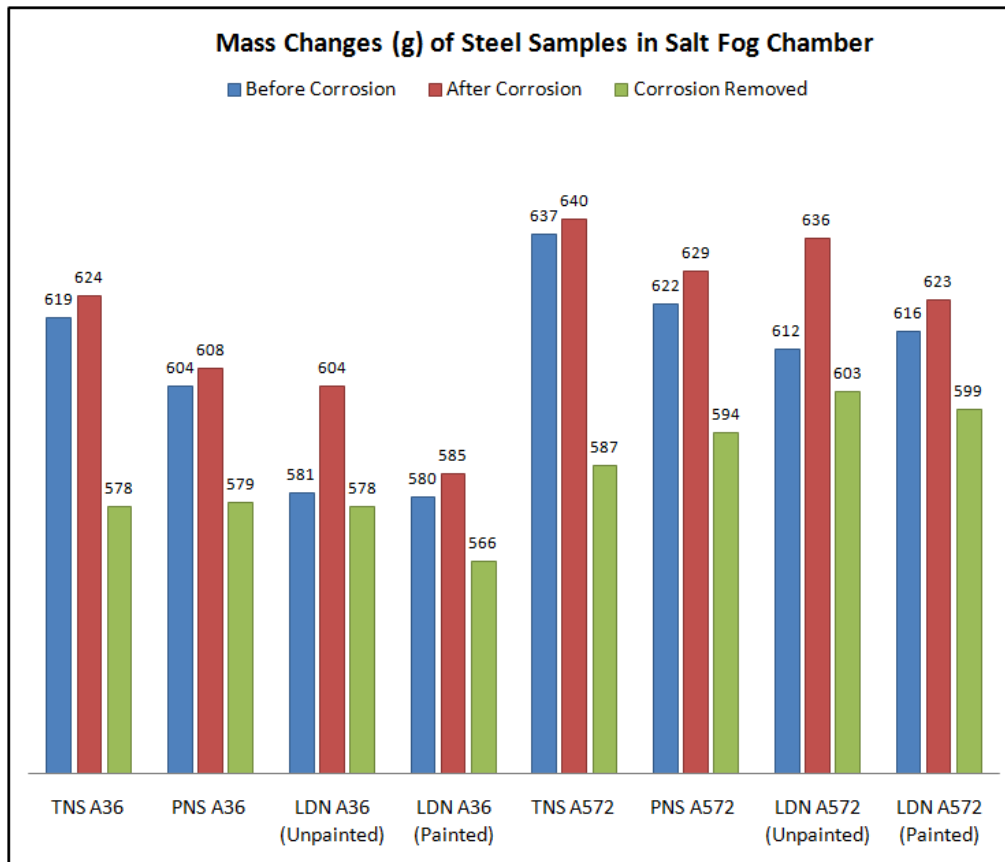
Figure 18: Mass changes of steel samples in the salt fog test chamber.

The salt fog chamber test results show that the salt fog testing chamber is more aggressive than the actual environment where the non-skid is used. It should be noted that ASTM B 117 calls for the use of a 5% salt water solution in the chamber and a solution of 10% sodium chloride was actually used. Daily temperature records were not provided. The mass changes of the samples in the test chamber are displayed in figure 18. The aluminum samples showed some staining from the corrosion product of the steel samples, but showed no mass change or noticeable corrosion. The aluminum samples visually showed only a loss of sheen.

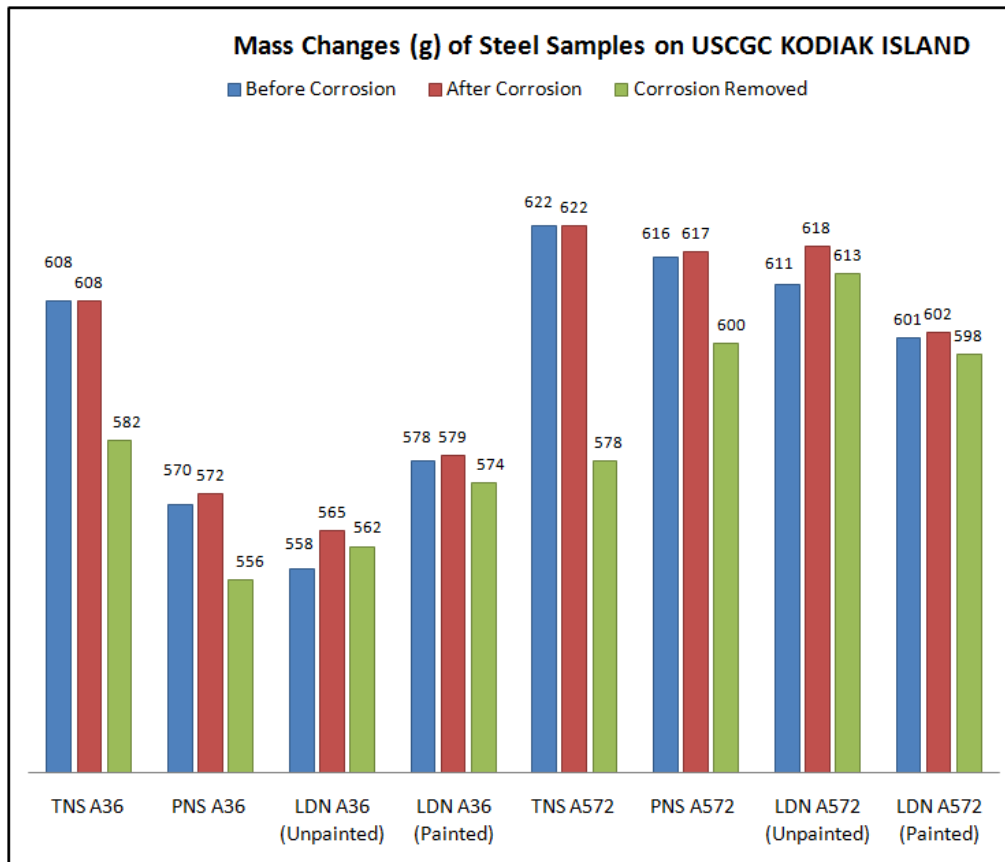
Figure 19: Mass changes of steel samples onboard CGC KODIAK ISLAND.

The results of the corrosion test onboard the CGC KODIAK ISLAND were similar to the results of the salt fog test, but with less severity. The aluminum samples experienced no change in mass, no visible staining or corrosion, but only a loss of sheen. The steel non-skid samples experienced less corrosion, but color fade was evident due to the exposure to sun. After the test some of the samples had some green color likely due to brass shavings on the deck since the test samples were placed below the 25 mm machine gun. The mass changes of the samples in the test chamber are displayed in figure 19.

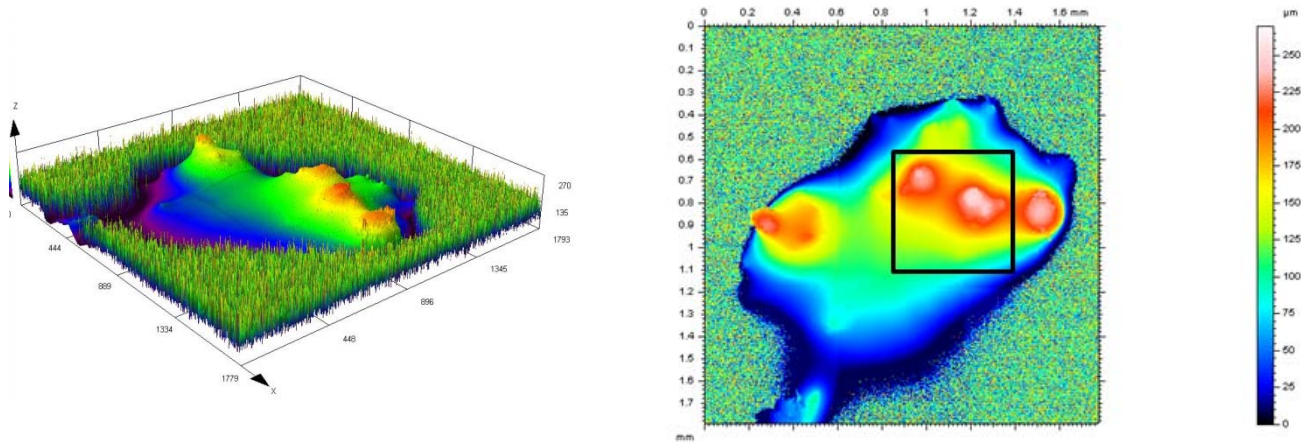
Figure 20: LDN A572 screenshot from Olympus measurement (left) and imported into Mountains™ with high point identified (right).

Images taken on the Olympus confocal microscope were imported into Sfrax© to measure roughness parameters and area-scale fractal analysis. The TNS A36 sample was not saved properly, so that sample was omitted from the comparison. Comparisons among materials were observed for pre-wear and post-wear characteristics. The LDN A572 sample images and calculated roughness parameters are shown below in figures 20 and 21. The samples were at the upward limits the stand-off distance for the Olympus confocal microscope and care had to taken to prevent damaging the lens during the measurement process. The maximum peak to valley heights exceeded the working distances for the 50X and 100X lens, so measurements were limited to the 20X lens. The maximum vertical range of the triangulation sensor on the UBM Profiler was  $\pm 3\text{mm}$ , so only the PNS was able to be measured with the UBM Scanning Laser Profiler.

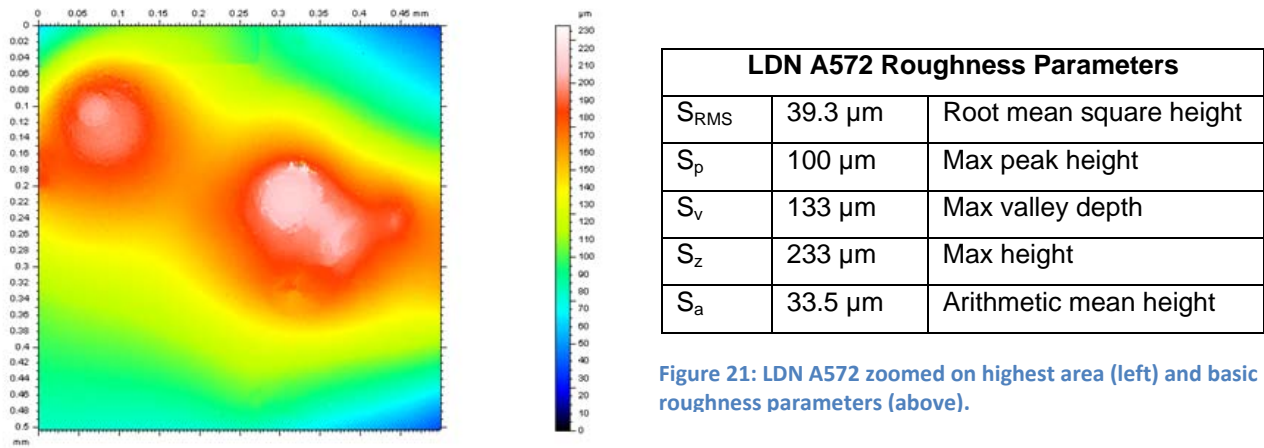
Figure 21: LDN A572 zoomed on highest area (left) and basic roughness parameters (above).

Roughness parameters  $S_a$  and  $S_z$  for all samples before and after wear testing are summarized below in table 7. The parameter  $S_a$  is the arithmetic mean height and  $S_z$  is the maximum peak to valley height of the surface. The post wear measurements were not completed on the PNS since the surface was gone after the initial wear test and the TNS A36 data was not saved properly and lost. The data shows that the basic roughness parameters of TNS and LDN are similar, yet the LDN post-wear measurements do not drop as significantly as the TNS measurements, however, a larger set of samples and measurements are needed to establish trends.

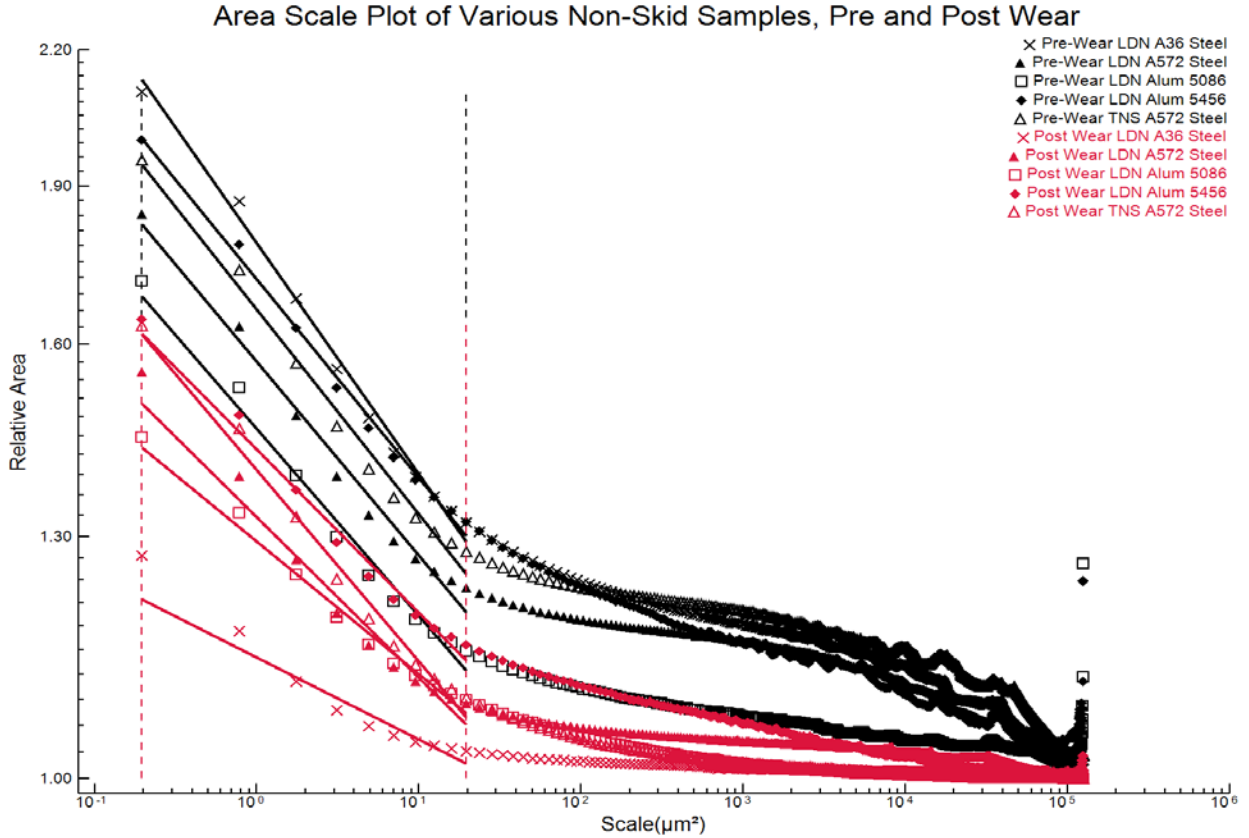
Figure 22: Mean relative area as a function of scale for selected non-skid materials.

Figure 22 shows the mean relative area as a function of scale for selected non-skid materials (unfiltered) before and after wear testing. The area scale plots of the samples are distinct with some overlap of the pre-wear LDN 5086 and the post wear LDN 5456. The overlap is realistic since the LDN 5456 was only worn to 50 cycles while the LDN 5086 was worn to 500 cycles. Otherwise the difference between pre and post wear samples is clear.

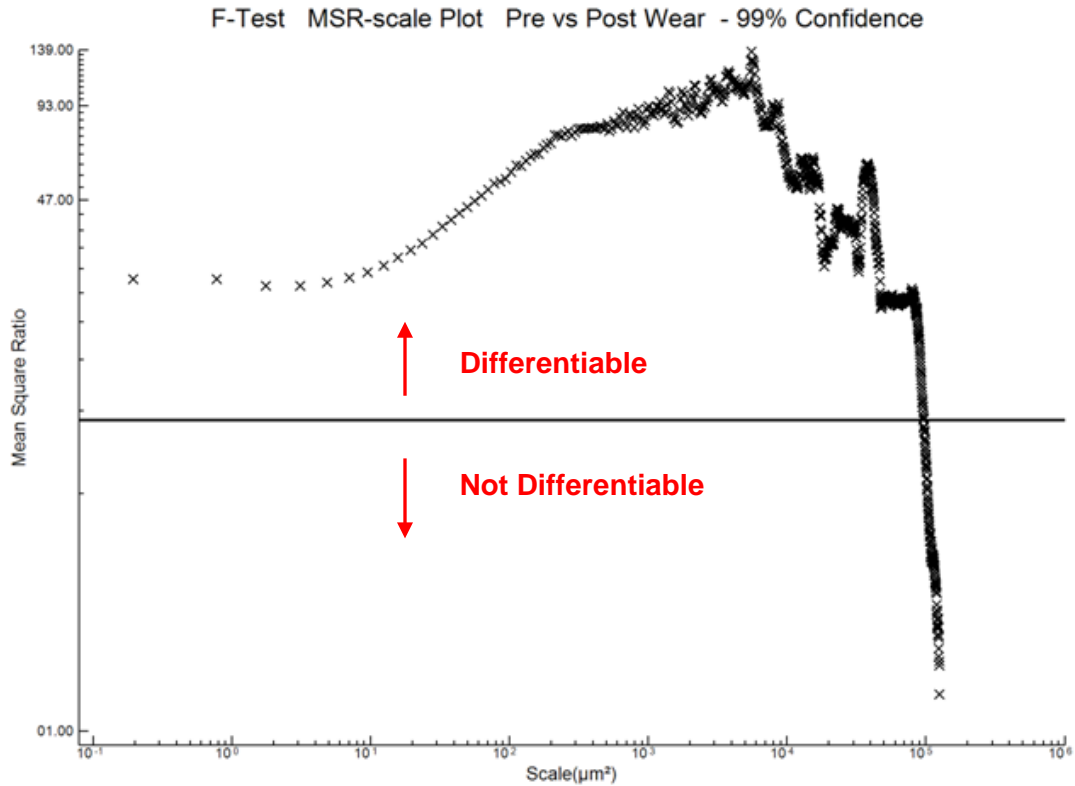
Figure 23: MSR-scale plot from F-test of significance analysis with 99% confidence.

F-tests of significance are used to compare the ability of the measurement parameters to differentiate among the samples. The mean square ratio (MSR) is calculated and is used to determine a confidence level that the two sets of measurements can be differentiated by the parameters (Brown 2006). The plot showing F-test significance comparing pre-wear parameters with post-wear parameters with 99% confidence is shown below. The plot shows that the samples are differentiable below scales of  $10^5 \mu\text{m}$ .

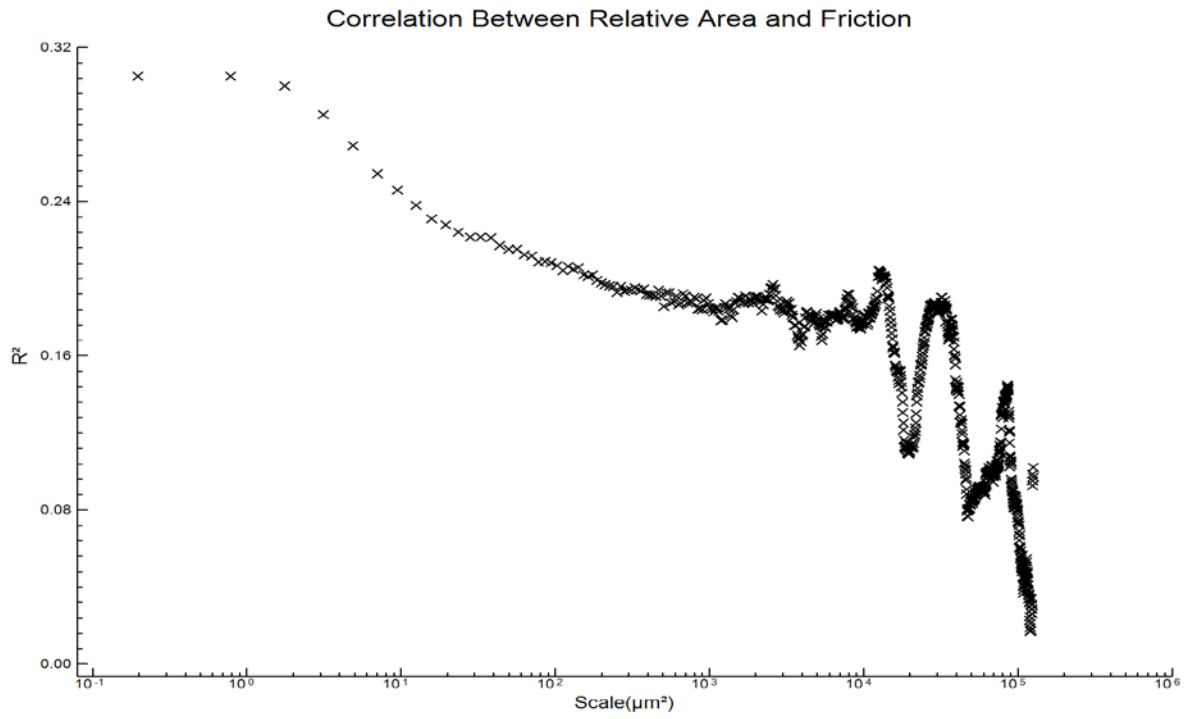
Figure 24: Correlation coefficient,  $R^2$ , for the correlation between relative area and friction at 804 scales.

Since friction is an important parameter in the design and performance of non-skid, the COF was one the functional properties examined in this research. Since contamination issues were experienced and the COF values are questionable, an analysis was run to correlate the calculated mass loss of non-skid to relative area. An area-scale plot was created for the non-skid samples that were worn to 500 cycles (TNS A572, LDN A36, LDN A572, and LDN 5086). Neither the friction parameter nor the wear mass loss parameter correlated well with relative area. It is possible that good correlations exist at different scales or for specific roughness parameters, such as the inclination on the surface (Berglund, et al. 2010). The correlation plots between relative area and friction and relative area and wear mass loss at 804 scales are shown below.

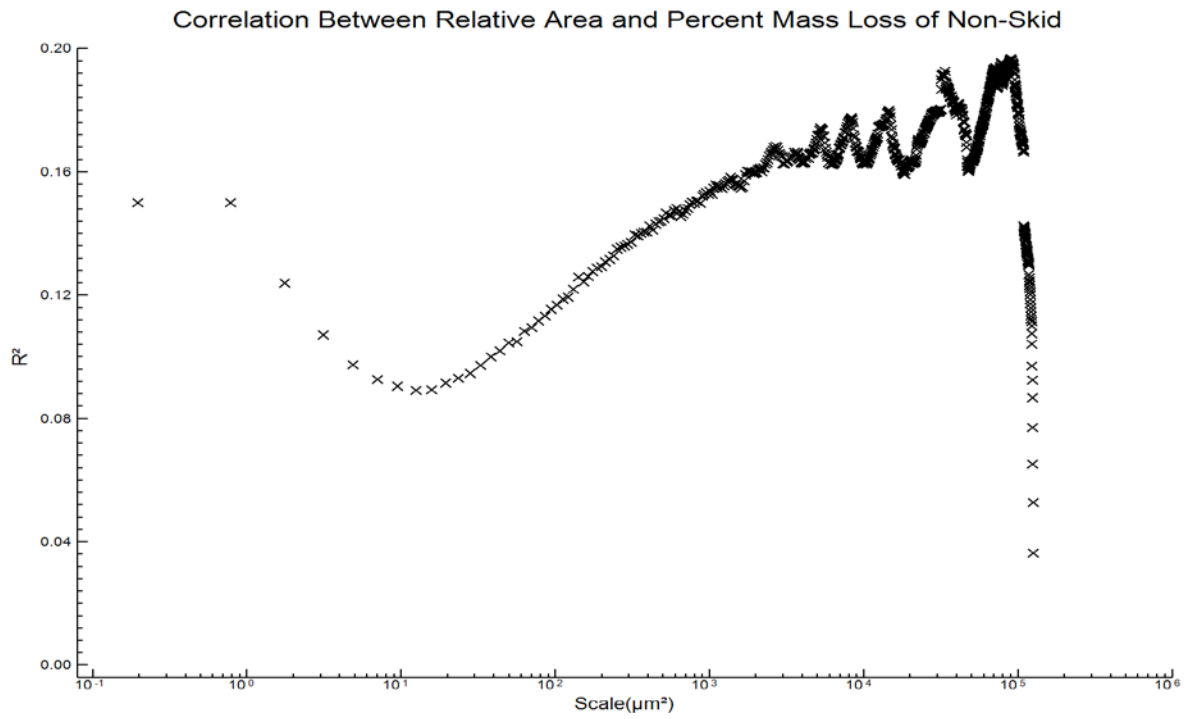
Figure 25: Correlation coefficient,  $R^2$ , for the correlation between relative area and mass loss at 804 scales.

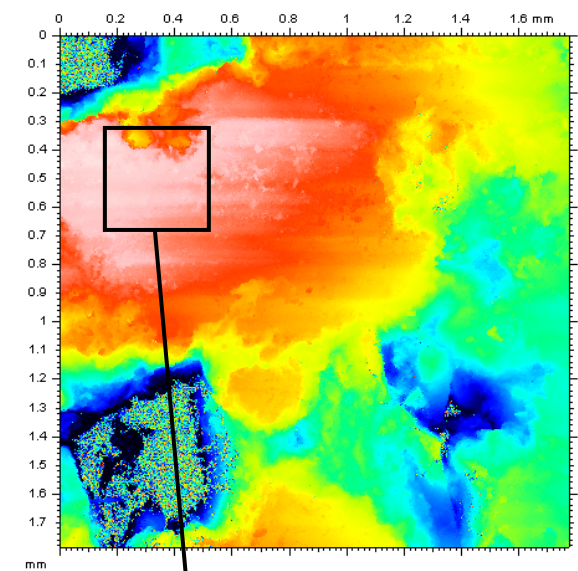
Height Parameters			
Sq	62.3	μm	Root mean square height
Ssk	-0.257		Skewness
Sku	2.24		Kurtosis
Sp	124	μm	Maximum peak height
Sv	145	μm	Maximum pit height
Sz	269	μm	Maximum height
Sa	52.7	μm	Arithmetic mean height

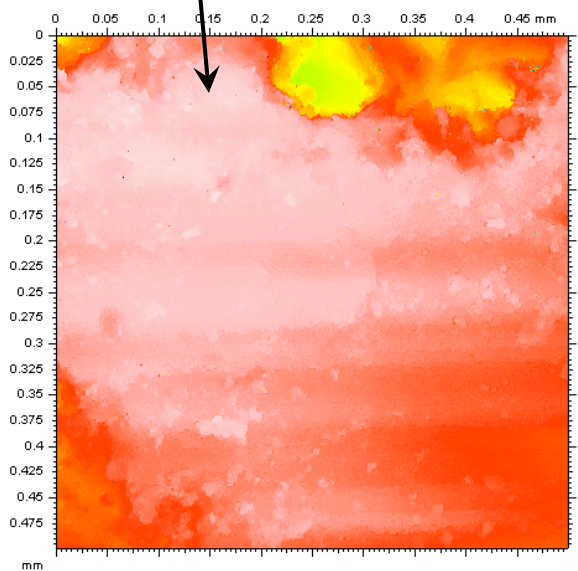
Height Parameters			
Sq	14.3	μm	Root mean square height
Ssk	-1.92		Skewness
Sku	8.42		Kurtosis
Sp	33.4	μm	Maximum peak height
Sv	178	μm	Maximum pit height
Sz	212	μm	Maximum height
Sa	10.2	μm	Arithmetic mean height

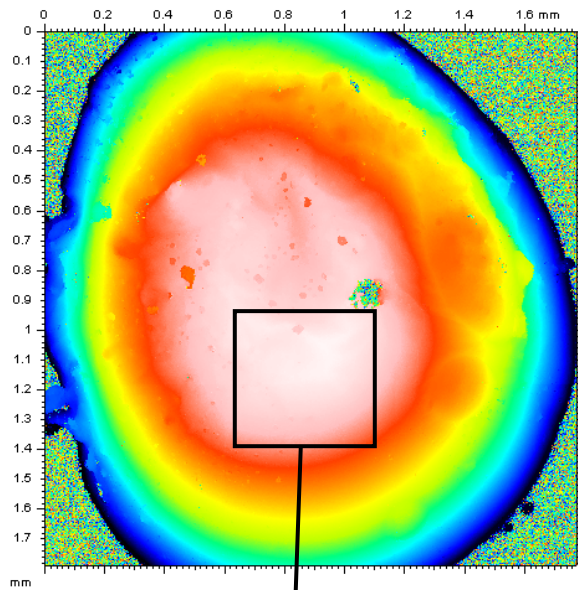
# LDN 5086: Pre-Wear

Sq	0.158	mm	Root mean square height
Ssk	-0.36		Skewness
Sku	1.99		Kurtosis
Sp	0.250	mm	Maximum peak height
Sv	0.337	mm	Maximum pit height
Sz	0.587	mm	Maximum height
Sa	0.136	mm	Arithmetic mean height

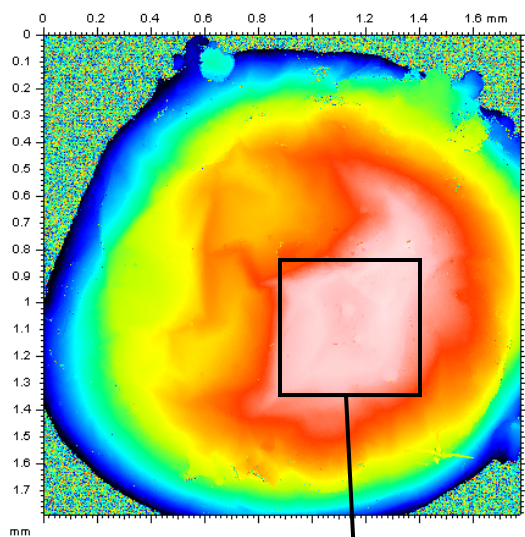
LDN 5456: Pre-Wear

Height Parameters					
Sq	0.140	mm		Root mean square height	
Ssk	-0.344			Skewness	
Sku	2.10			Kurtosis	
Sp	0.260	mm		Maximum peak height	
Sv	0.310	mm		Maximum pit height	
Sz	0.570	mm		Maximum height	
Sa	0.119	mm		Arithmetic mean height

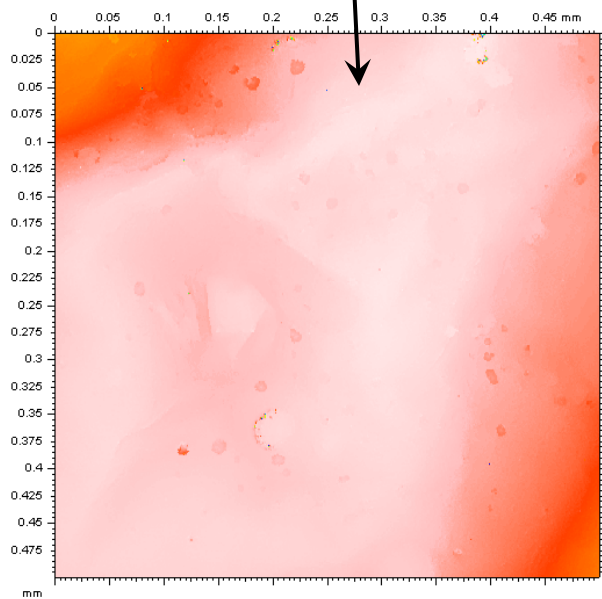
Height Parameters					
Sq	0.0229	mm		Root mean square height	
Ssk	-1.79			Skewness	
Sku	9.16			Kurtosis	
Sp	0.0483	mm		Maximum peak height	
Sv	0.421	mm		Maximum pit height	
Sz	0.470	mm		Maximum height	
Sa	0.0171	mm		Arithmetic mean height

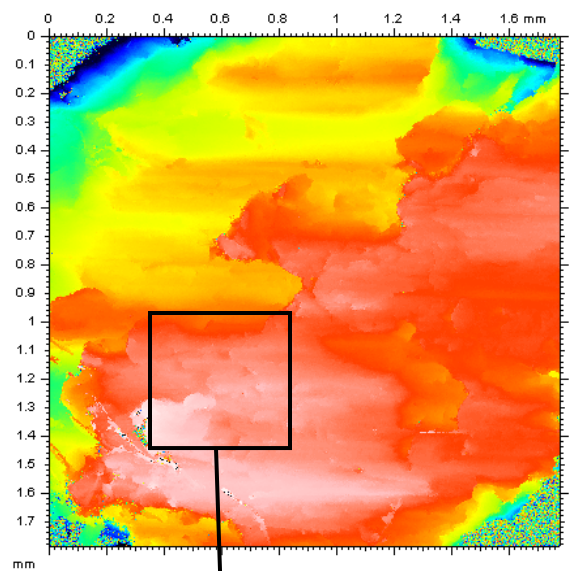
LDN 5456: Post Wear (50 cycles)

Height Parameters			
Sq	45.5	μm	Root mean square height
Ssk	-1.35		Skewness
Sku	4.90		Kurtosis
Sp	82.5	μm	Maximum peak height
Sv	191	μm	Maximum pit height
Sz	273	μm	Maximum height
Sa	35.8	μm	Arithmetic mean height
